# **High Definition Stream Surveys of Turkey Creek, AL: Sample Report**

**May 1, 2015**

**Trutta Consulting  
and  
Parham & Associates Environmental Consulting**

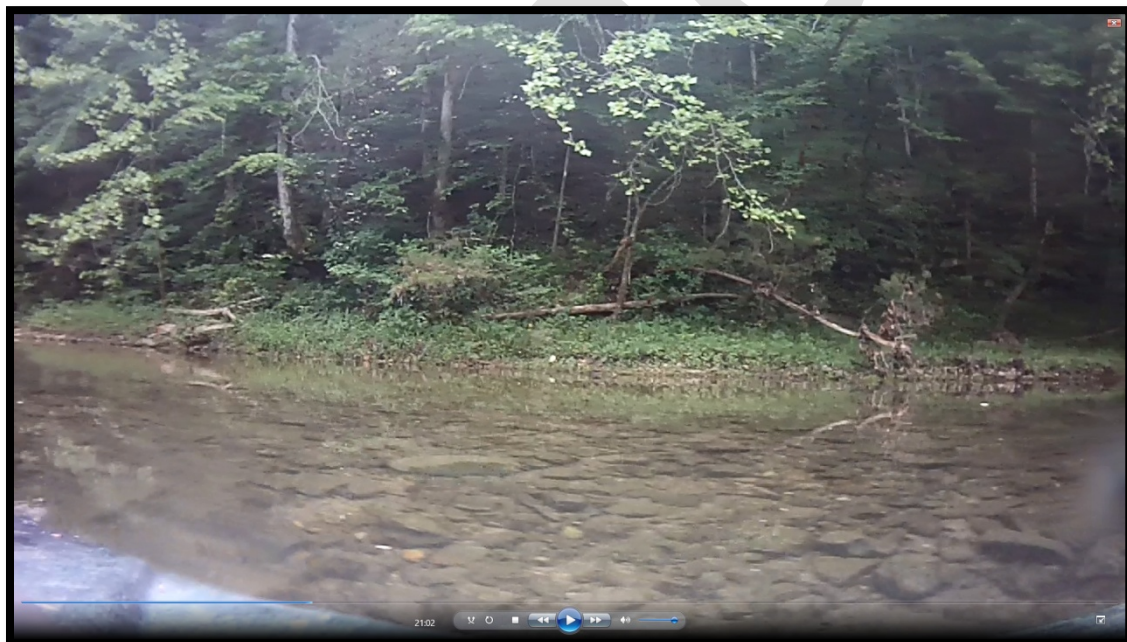
Figure 5: Level 1, Optimal Condition: Banks currently in optimal condition with excellent surface protection and low erosion potential. Includes stabilized areas such as bedrock outcroppings, heavily wooded areas, banks with low slopes and with good access to flood plain. No action necessary.

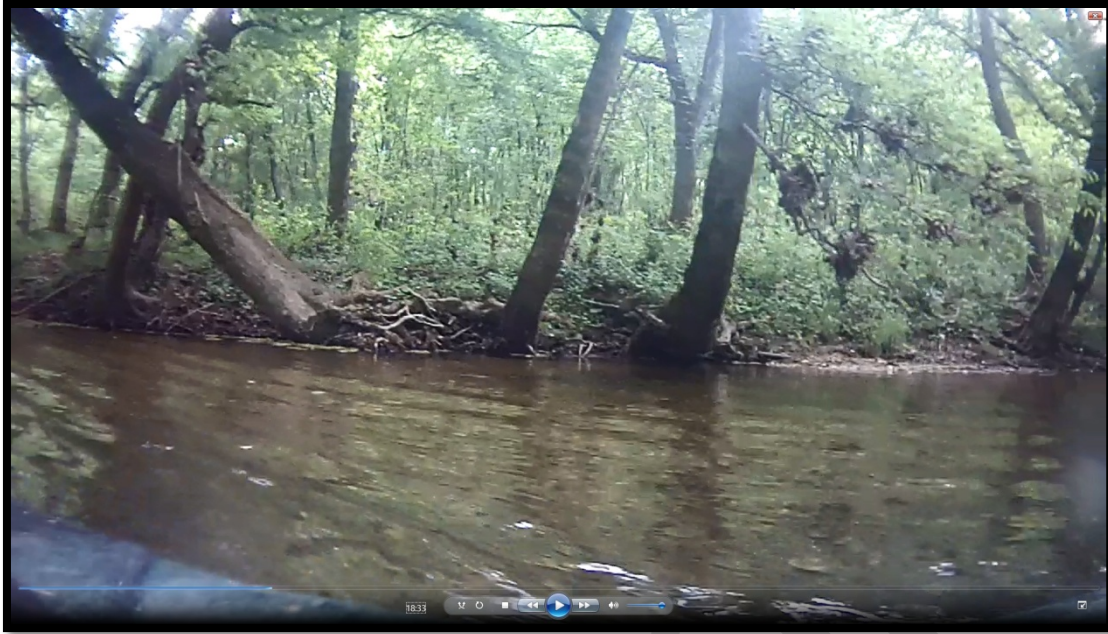
Figure 6: Level 2, Good Condition: Banks currently in good condition with minor impacts present. Includes heavily forested areas with moderate bank angles and adequate access to flood plains. No action necessary.

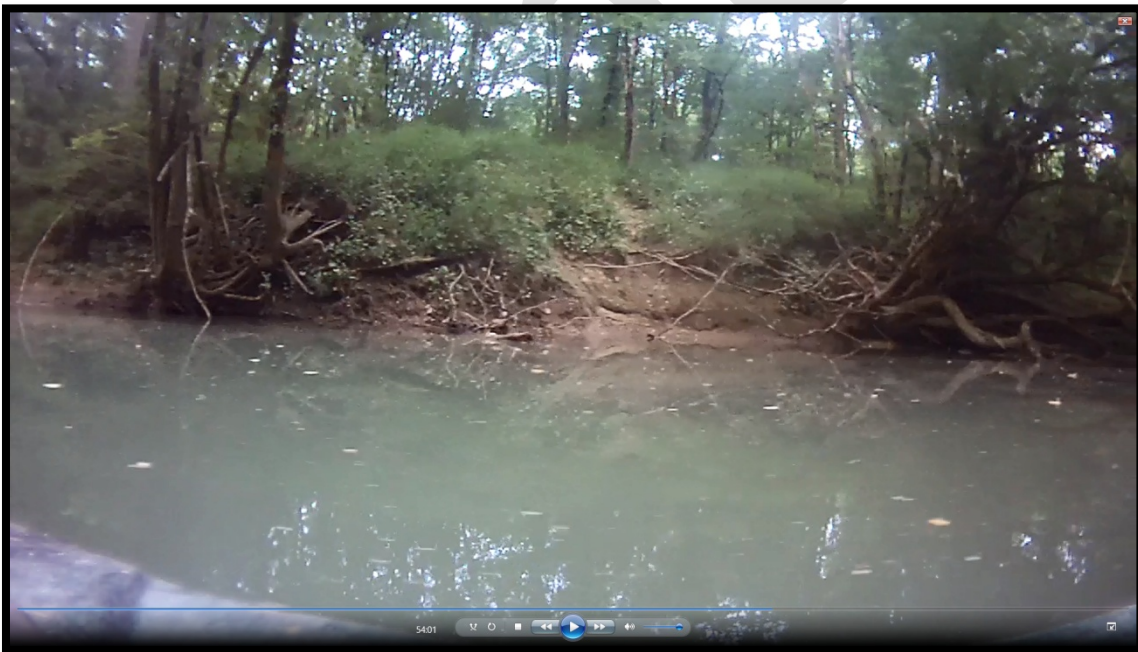
Figure 7: Level 3, Fair Condition: Banks showing moderate erosion impact with limited access to flood plain and variable surface protection. Potential impacts affecting water quality and aquatic habitat. Immediate action is not necessary.

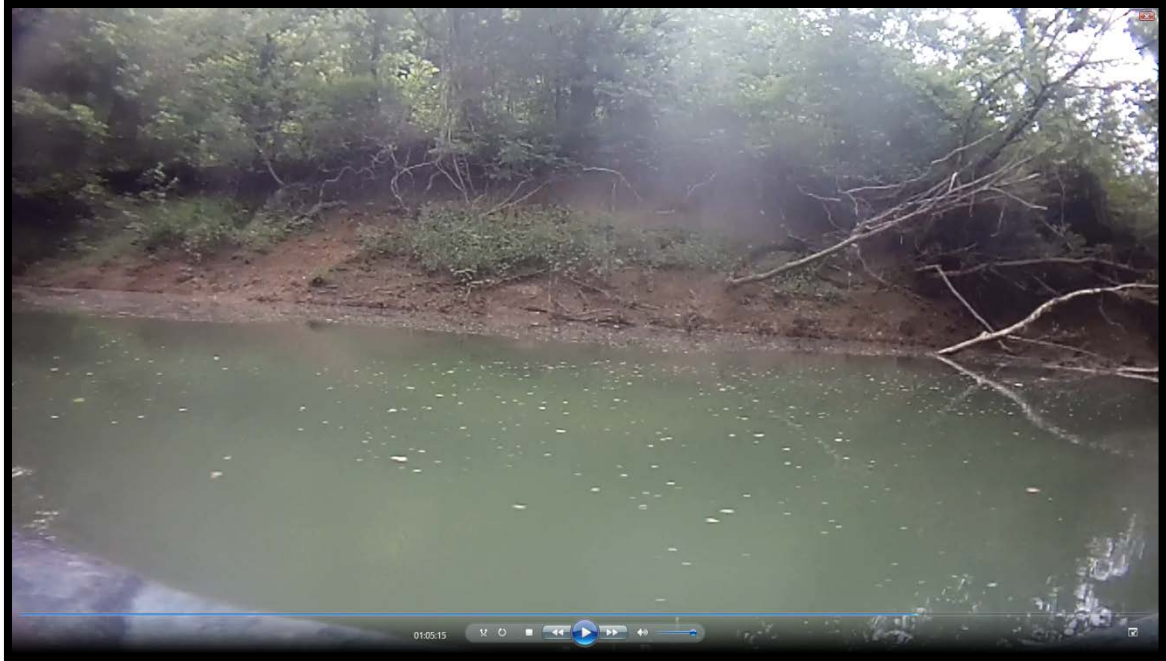
Figure 8: Level 4, Poor Condition: Banks with high erosion potential consisting of few trees and grass. Obvious impacts from cattle, agriculture, industry, with minimal connectivity to the flood plain. Source of negative impacts to water quality and aquatic habitat. Recommended action site.

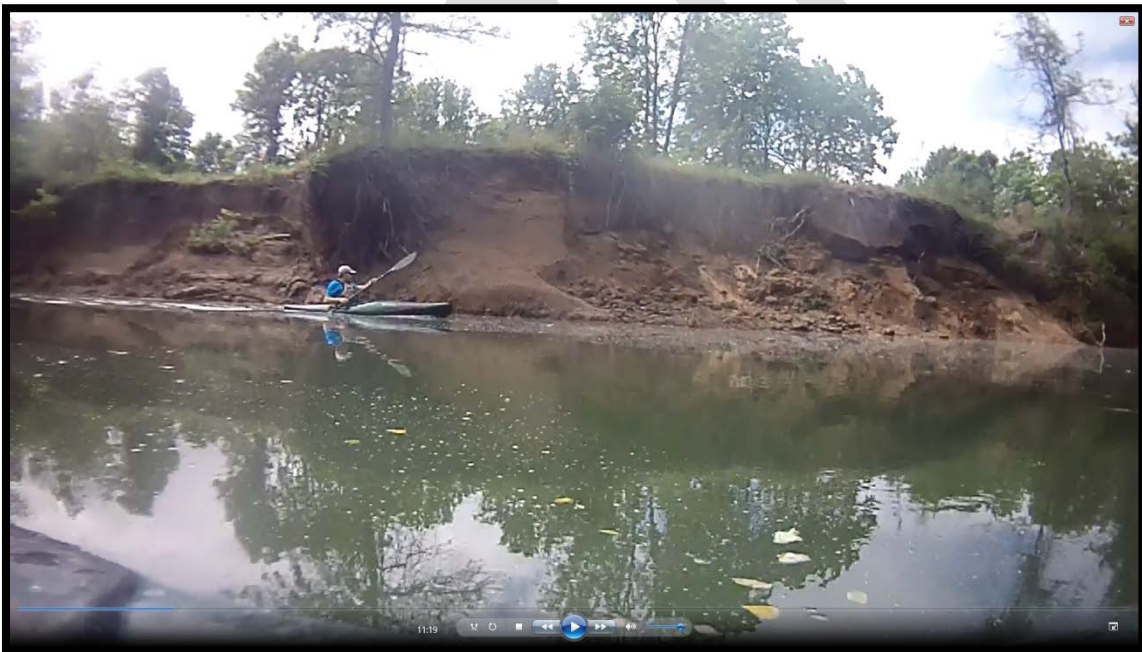
Figure 9: Level 5, Very Poor Condition: Banks with the highest erosion potential and steep bank angles. Evidence of active bank failure, with very little stabilization from vegetation. Obvious impacts from cattle, agriculture, and industry with no connectivity to flood plain. Contribution of sediment is very high in these areas. High source of negative impacts to water quality and aquatic habitat. Highly recommended action site.

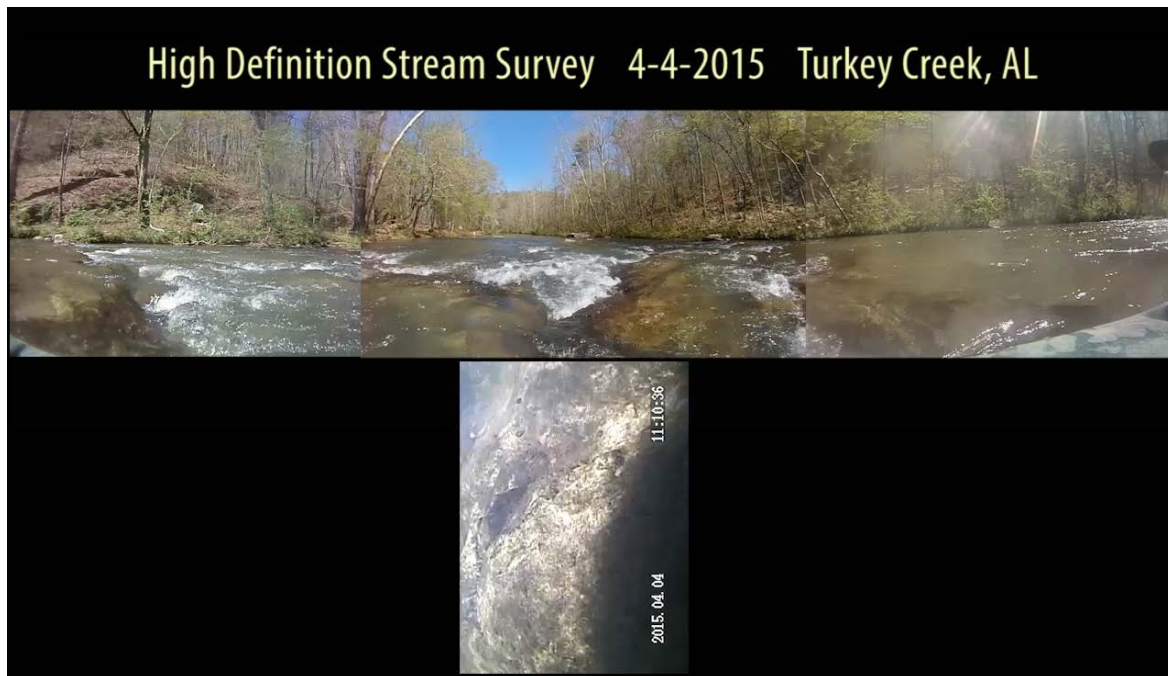
Figure 11: An example of the video from the kayak HDSS in a good section of Turkey Creek.

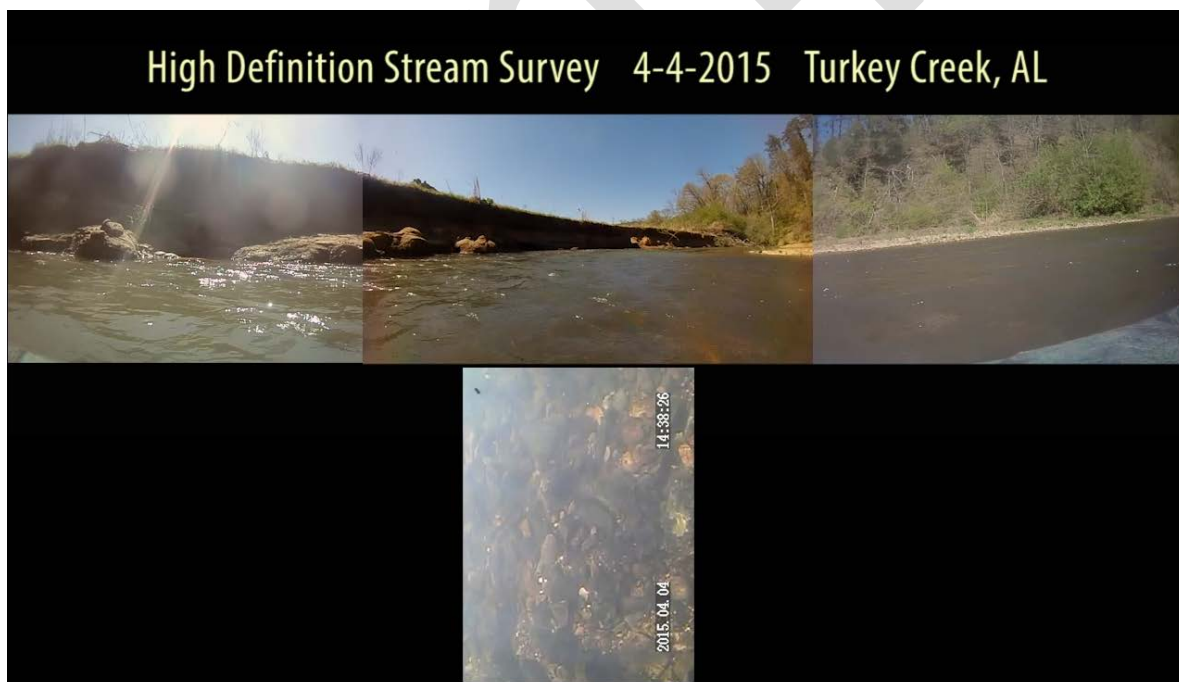
Figure 12: An example of the video from the kayak HDSS in a poor quality section of Turkey Creek. Note the bank failure on the left side of the image.

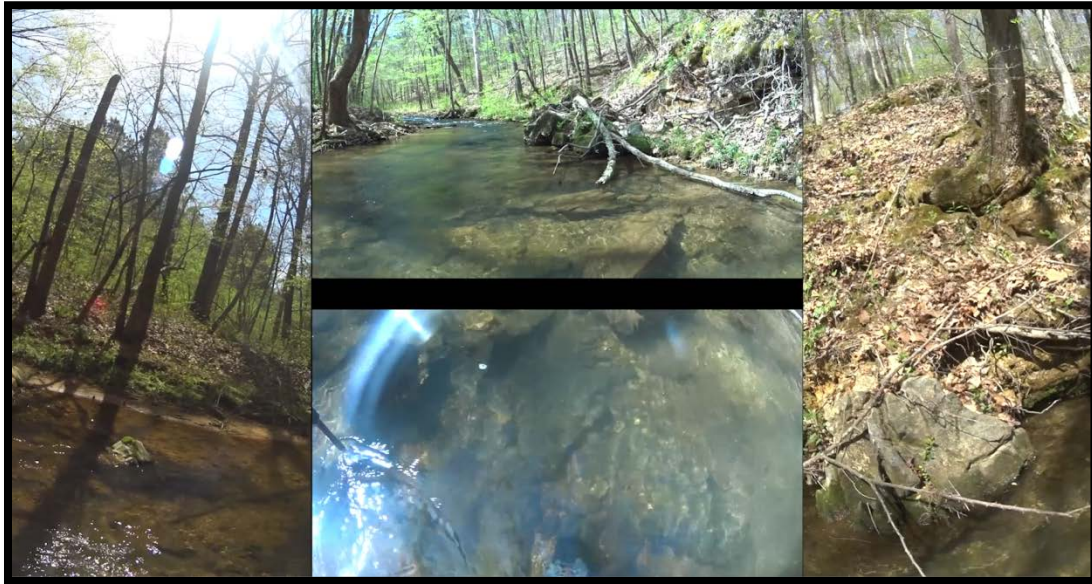
Figure 13: An example of the video from the backpack HDSS in a good section of Turkey Creek.

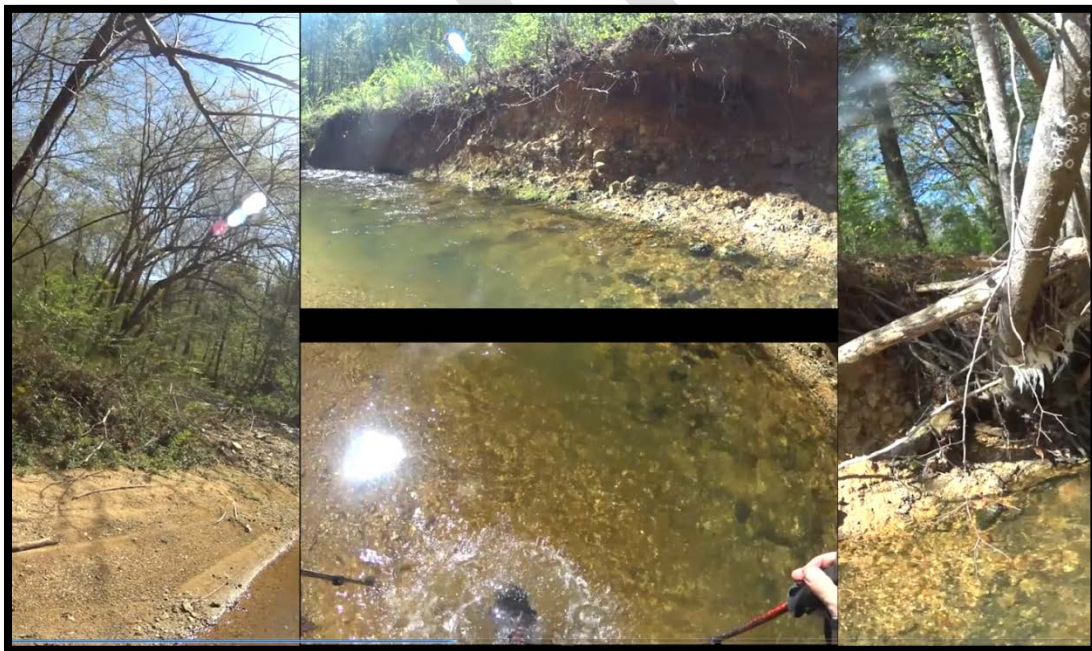
Figure 14: An example of the video from the backpack HDSS in a poor quality section of Turkey Creek. Note the bank failure on the right side of the image.

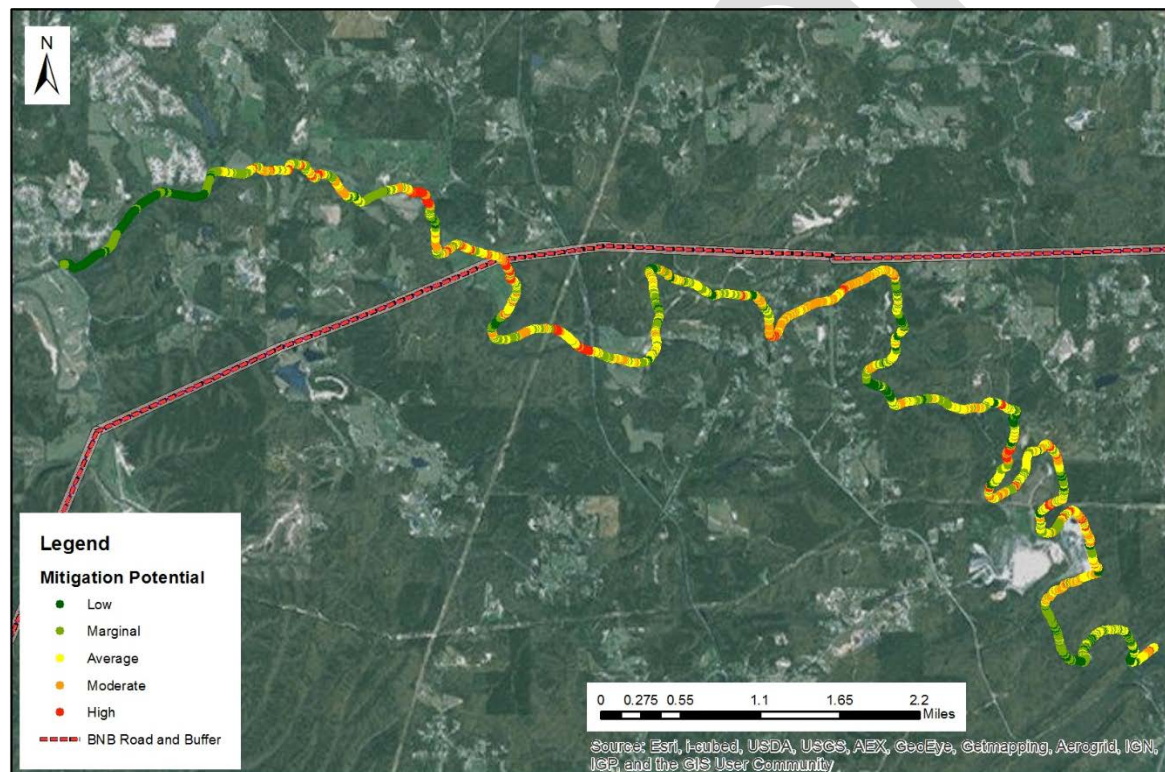
Map 18: Turkey Creek darter habitat mitigation potential output from the High Definition Stream Survey.

Map 18 - Map 21 show the whole project area as well as three additional maps for the upper, mid, and lower section associated with potential mitigation locations. The results show that restoration areas may be found throughout the stream segment and some are in close proximity to the BNB crossing location. Combining these results with land ownership, access, and other information would further aid in selecting the most cost effective mitigation locations..
