# **High Definition Stream Surveys of Turkey Creek, AL: Sample Report**

**May 1, 2015**

**Trutta Consulting  
and  
Parham & Associates Environmental Consulting**

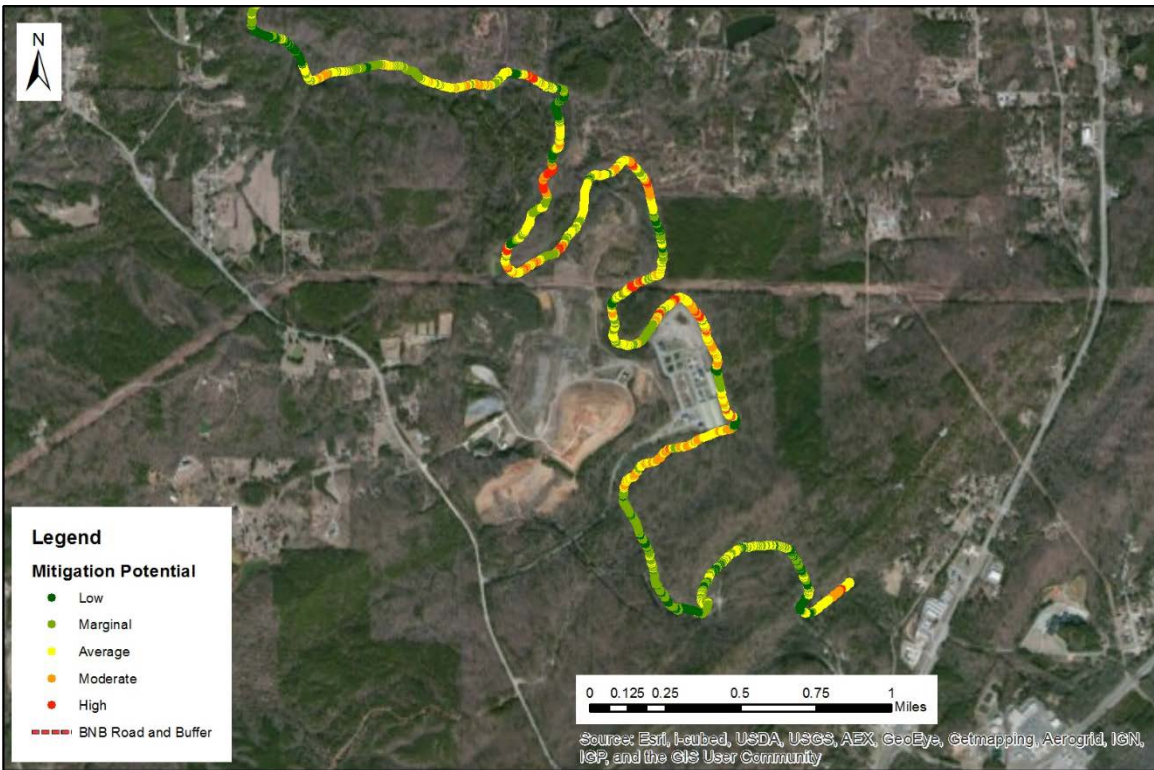
Map 19: Turkey Creek darter habitat mitigation potential output from the High Definition Stream Survey (upper section).

Map 18 - Map 21 show the whole project area as well as three additional maps for the upper, mid, and lower section associated with potential mitigation locations. The results show that restoration areas may be found throughout the stream segment and some are in close proximity to the BNB crossing location. Combining these results with land ownership, access, and other information would further aid in selecting the most cost effective mitigation locations..
